## PHYSICAL AND CHEMICAL PROPERTIES OF THE IMPLANT USED FOR DOUBLE PELVIC OSTEOTOMY/TRIPLE PELVIC OSTEOTOMY PROCEDURE IN DOGS

**Abstract:** This study aimed to determine the physical and chemical properties of a titanium alloy implant used to treat hip dysplasia in dogs. The scope of the study included examination of: surface morphology using light microscopy, optical profilometry, scanning electron microscopy, structure, hardness and hardness profile of the surface layer, adhesion of the surface layer, pitting corrosion resistance, wettability, chemical composition of the surface and passive layer using EDS and XPS. On the basis of the conducted tests, the quality of the implant was found to be satisfactory. The implant is made of biphasic Ti6Al4V alloy, it is characterized by a homogeneous surface topography, the hydrophilic surface layer is characterized by good adhesion to the substrate, the passive layer, formed on the substrate strengthened by vibratory treatment, consists mainly of titanium oxides and protects the implant from pitting corrosion. The specified set of physical and chemical properties of the implant indicates that it should be characterized by biocompatibility

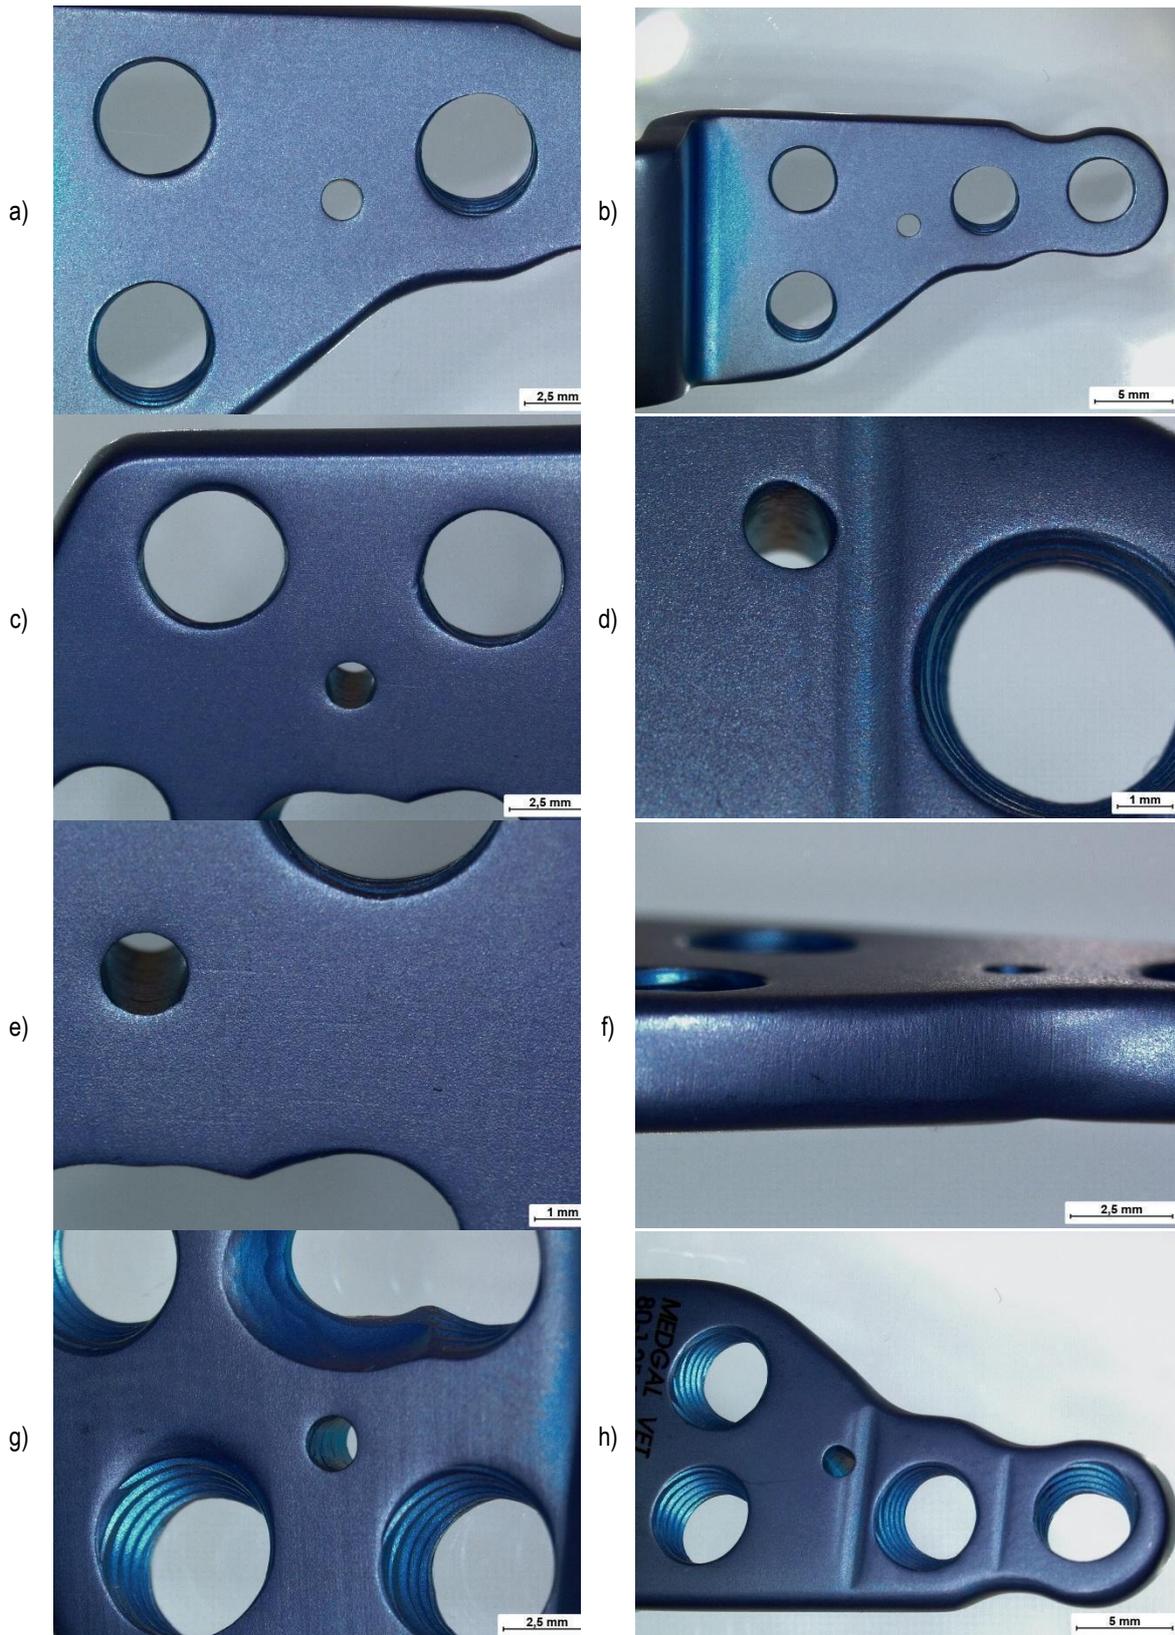
Fig. 2. Implant surface, light microscope

The surface of the implants is characterized by a heterogeneous, matte, blue color (Figure 2 a), the intensity of which changes slightly within the zones subjected to permanent deformation during the shaping of its structural form (Figure 2 b). The variation in color was also influenced by the heterogeneous topography of the implants, created during vibration processing - Figure 2 c, d, e. Moreover, scratches remaining after grinding are visible on the surface of the implants (Figure 2 e, f). They occur mainly on the side surfaces of the implants (Figure 2 f). No unwanted machining residues were observed in the threaded holes and screw sockets. These surfaces are also characterized by a blue color (Figure 2 g, h).

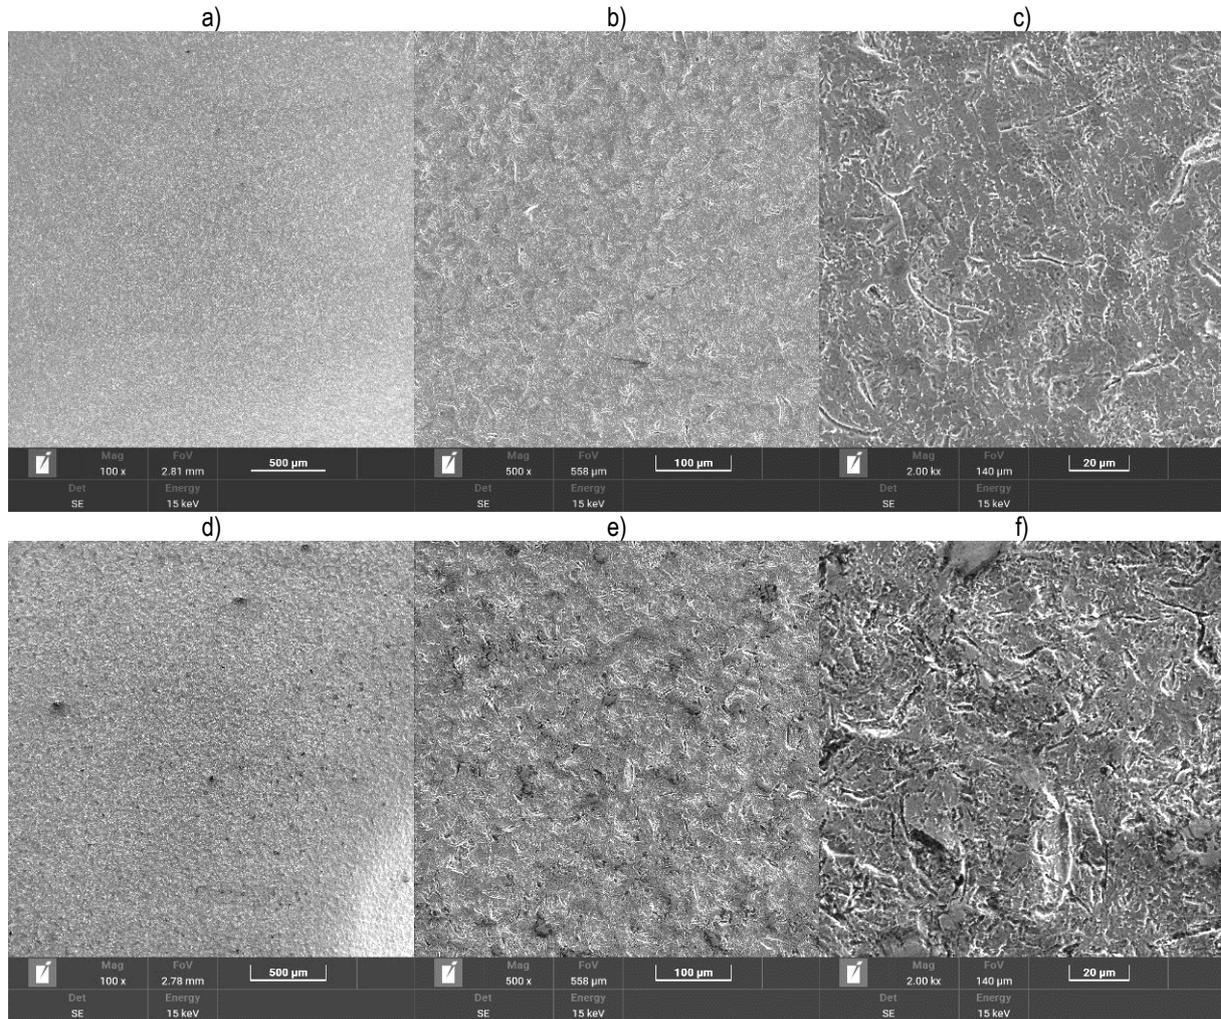
Fig. 3. Topography of the implant surfaces a-c) upper surface, d-f) lower surface, SEM

– scanning electron microscope  
 Microscopic examinations were performed on the upper and lower surfaces of the implant adjacent to the bone. Both surfaces

were characterized by similar topography. There were numerous, evenly distributed dents on the surface, which were remnants of vibration processing - Figure 3.

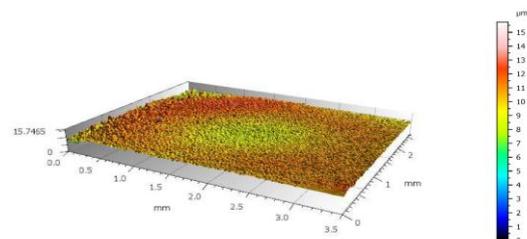
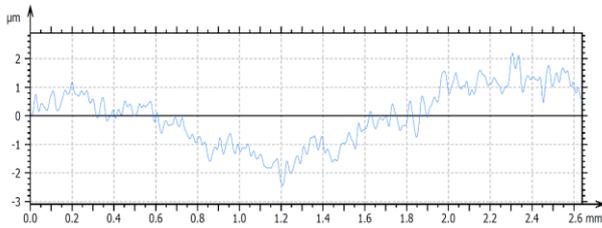
– optical profilometer  
 Analysis of the test results indicates varied surface roughness. The lower surface adjacent to the bone was characterized by greater roughness - Tables 1, 2. An example image of the external surface (3D) and profile of the implant is shown in Figures 4 and 5, respectively.

Fig. 4. 3D image of the implant external surface

Fig. 5. Profile of the implant external surface

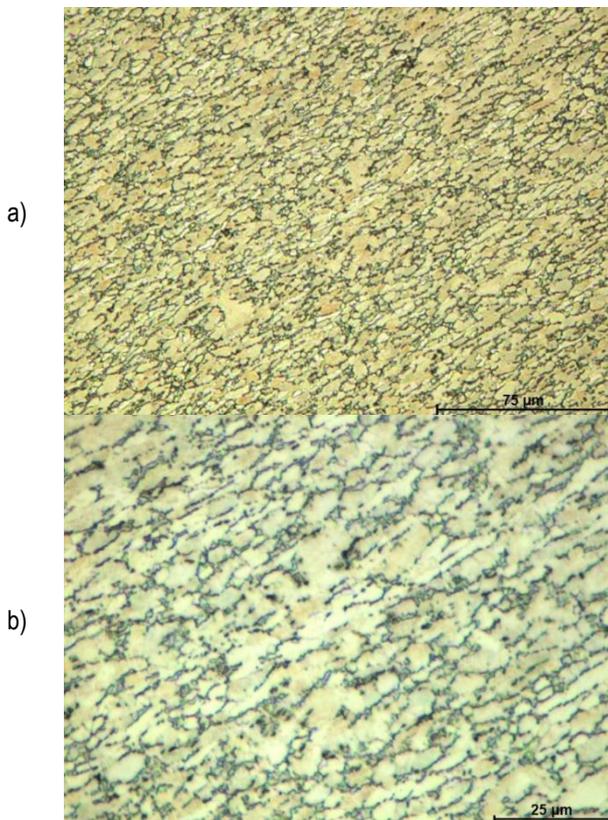
Fig. 6. Two-phase structure  $\alpha + \beta$  of the Ti6Al4V alloy (longitudinal section), light microscope

Based on the observations made, the correct structure of the material from which the plate was made was observed. Observations showed the existence of a two-phase structure  $\alpha + \beta$  - Figure 6. It was characterized by a homogeneous microstructure consisting of equiaxed grains of the  $\alpha$  phase and the  $\beta$  phase located at the grain boundary of the  $\alpha$  phase.

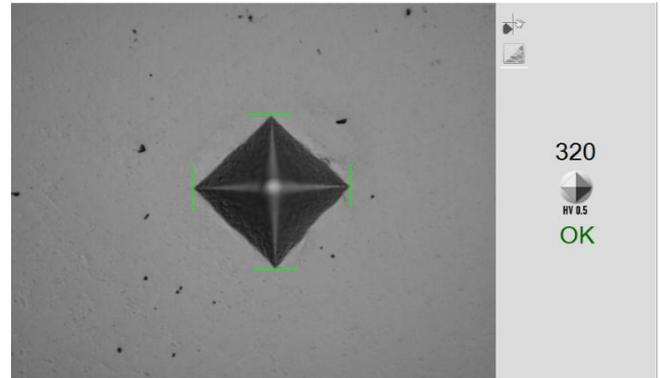
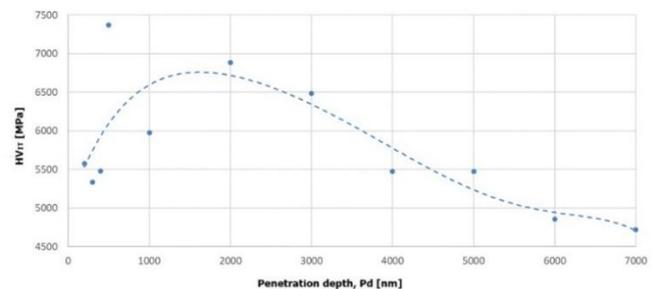
The measurements performed did not show significant differences in hardness on the longitudinal and cross-sections of the tested samples. It was found that the average hardness value was in the range of  $307 \pm 328$  HV0.5 - Figure 7.

Based on the analysis, different hardness values were shown depending on the distance from the implant surface. Higher

hardness was observed in the surface layer to a depth of approximately 4000 nm, compared to the core of the material. This effect may be the result of the strengthening of the material caused by the use of vibration treatment preceding the anodic oxidation process - Figure 8.

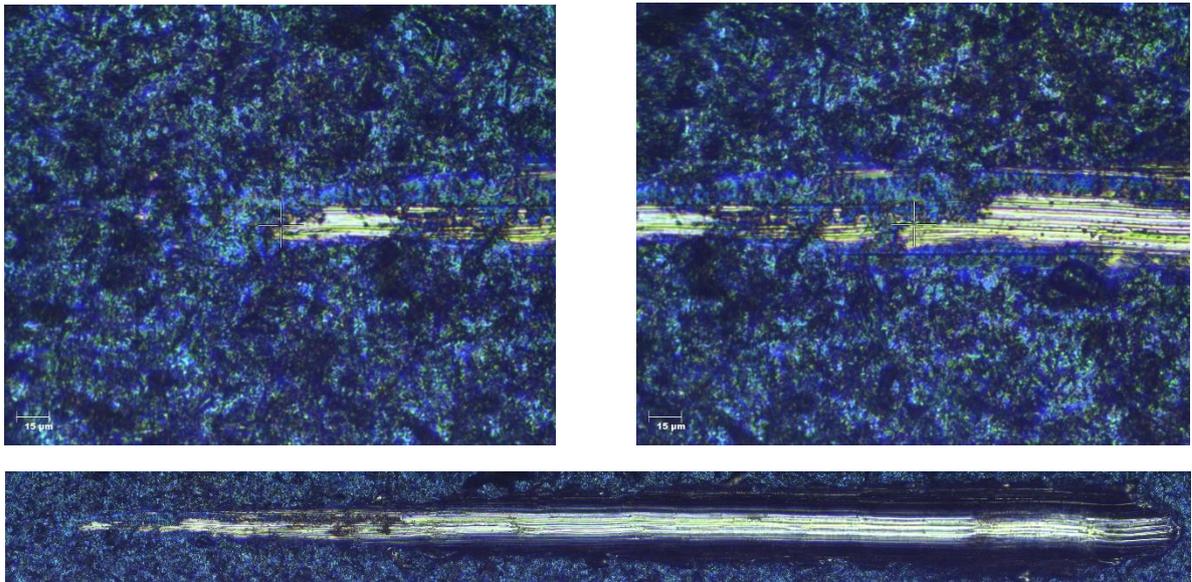
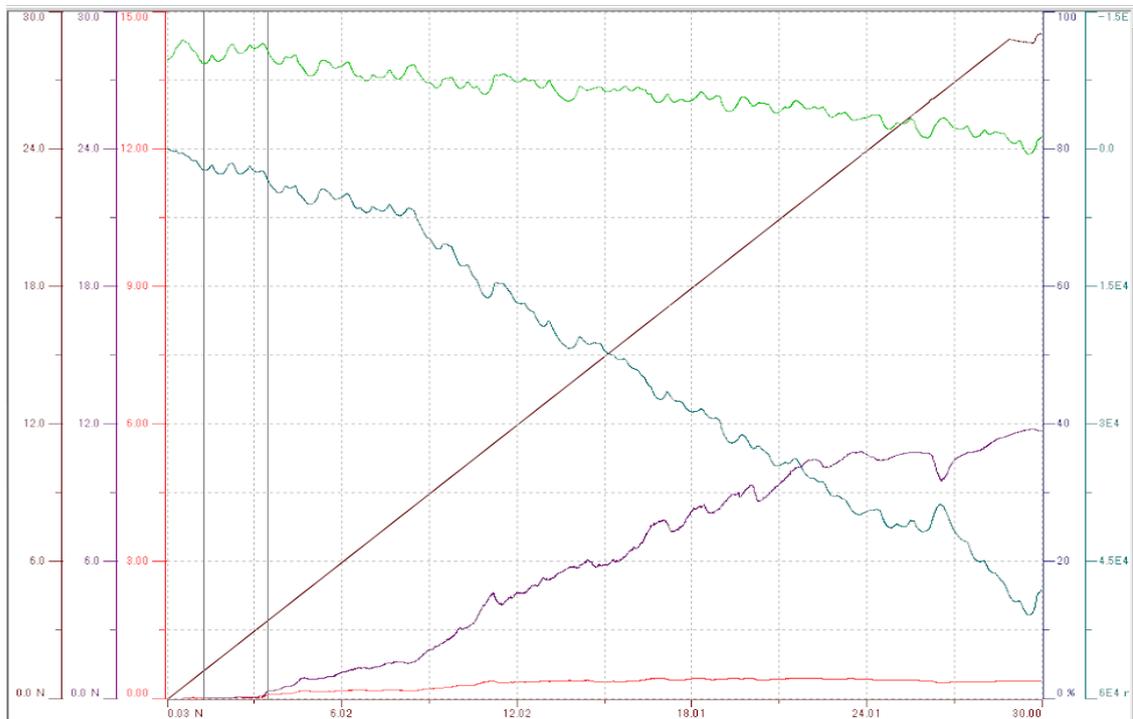
Fig. 9. Scratch and curves recorded during adhesion tests using the scratch test method (Fn – loading force, brown; Pd – scratch depth, blue; Ft – friction force, purple;  $\mu$  - friction coefficient, red; Rd - residual profile, green)

The analyzed coating was characterized by good adhesion to the substrate. Based on the measurements performed, it was found that the coating was chipped at a value of  $Lc_2 = 1.27 \pm 0.05$  N, and a complete break in its continuity was observed at a value of  $Lc_3 = 3.46 \pm 0.1$  N. Based on the macroscopic assessment of the scratch, discontinuous perforation of the coating was found. Examples of sample surface scratches and the curves recorded during the tests are shown in Figure 9.

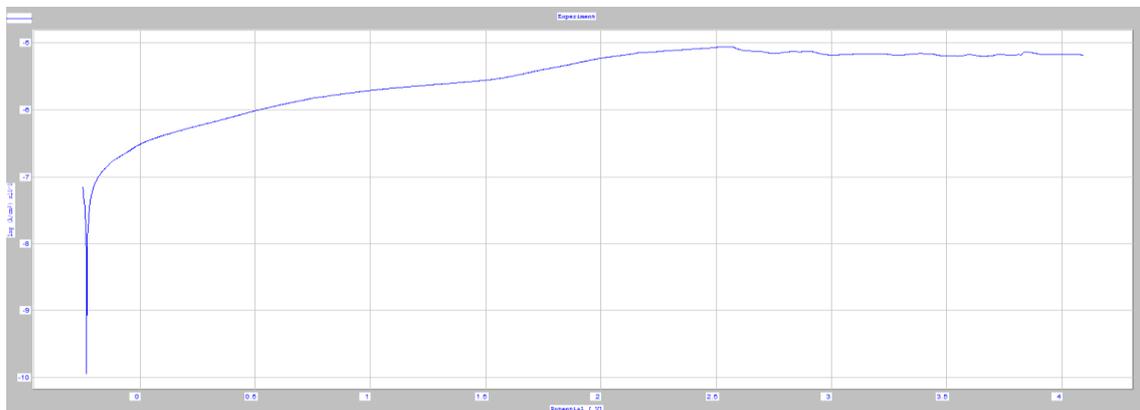
Fig. 10. Polarization curve of the sample taken from the implant

Polarization curves of samples obtained from the implant are characterized by the absence of hysteresis loops. This indicates effective passivation of the implant surfaces in the entire measurement range  $E = + 4000$  mV. In this range, no sudden increase in current density was observed, which would indicate the initiation of the corrosion process - Figure 10. This was confirmed by microscopic observations of the surfaces of samples after corrosion tests.

The average values of the corrosion potential  $E_{corr}$  and the polarization resistance  $R_p$  determined using the Stern method were  $E_{corr} = -255.5 \pm 10$  mV and  $R_p = 480.17 \pm 55$  k $\Omega$ cm<sup>2</sup>, respectively.

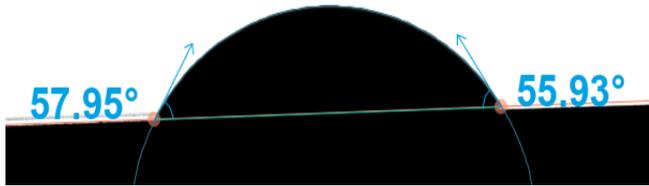
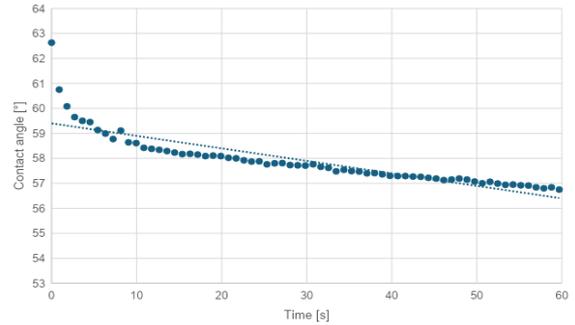
The value of the contact angle  $\theta$  of the tested surfaces was in the range of  $56.4 \pm 58.8^\circ$ . The average value of the contact angle was  $\theta = 57.5 \pm 2.4^\circ$ . The obtained results demonstrate the hydrophilic nature of the surface. Figure 11 shows an example droplet. Figure 12 shows the water contact angle as a function of time.

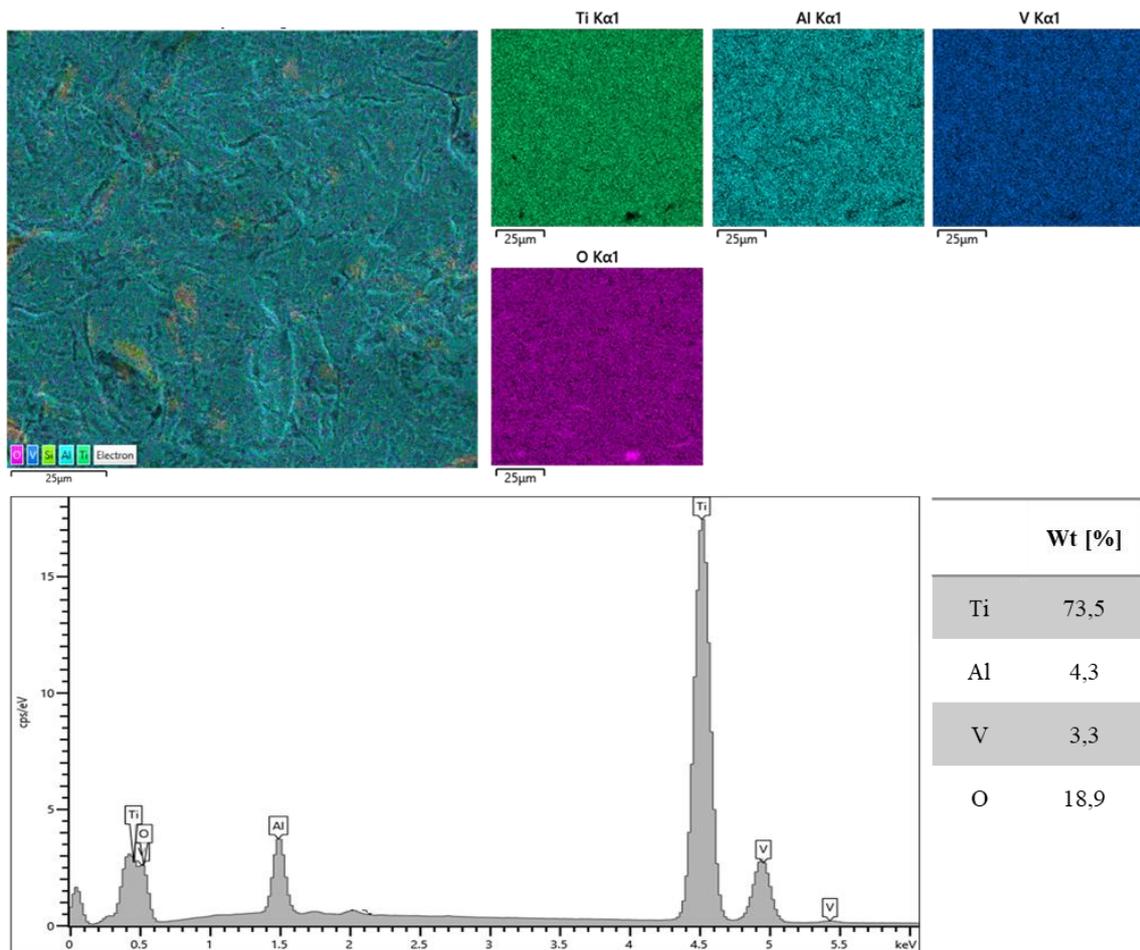
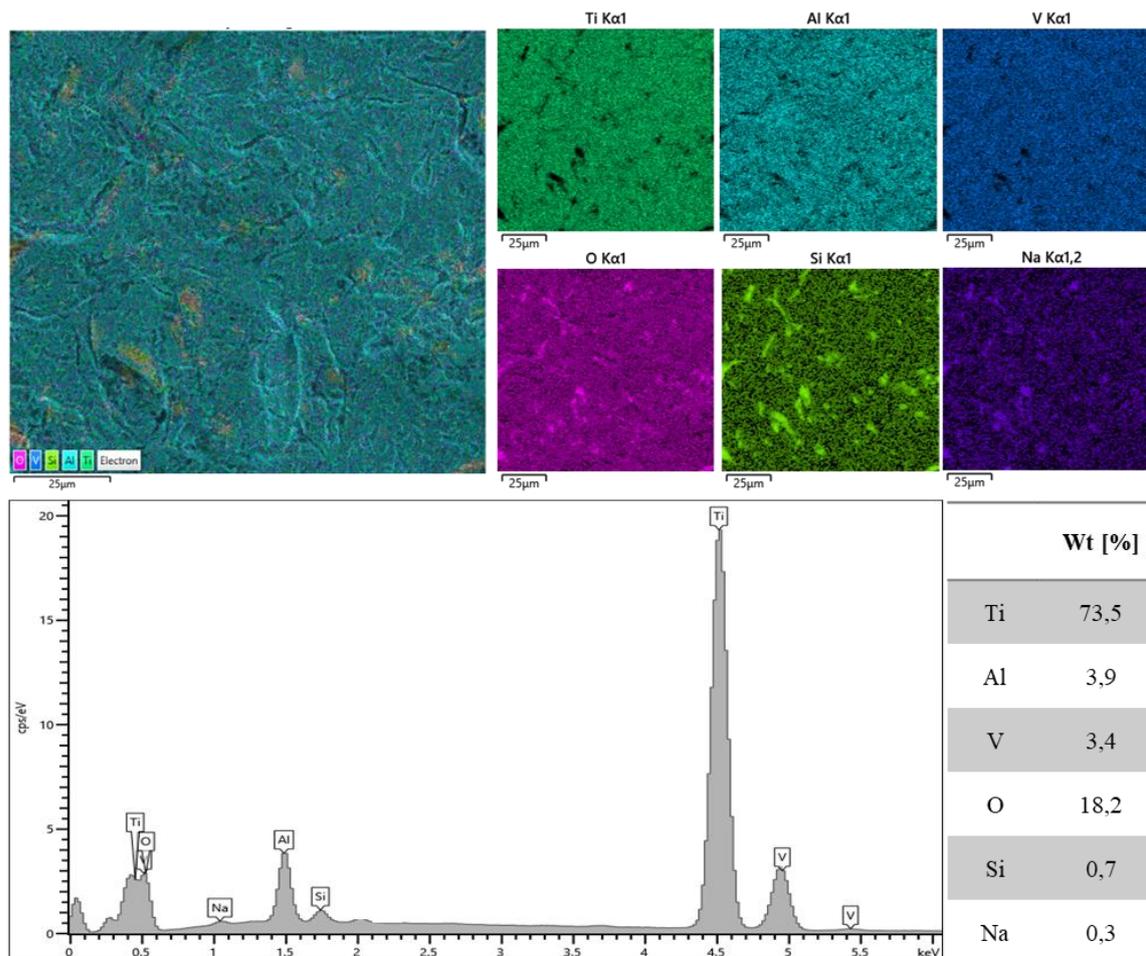
Analysis of the chemical composition of the implants' surface layer showed that they consist mainly of Ti, O, Al and V. Moreover, in the lower surface layer of the implants (adjacent to the bone), the presence of Si and Na, which are remnants of vibration processing, was found. The surface image, overview spectrum and element distribution of the upper and lower surface layers are shown in Figures 13 and 14, respectively.

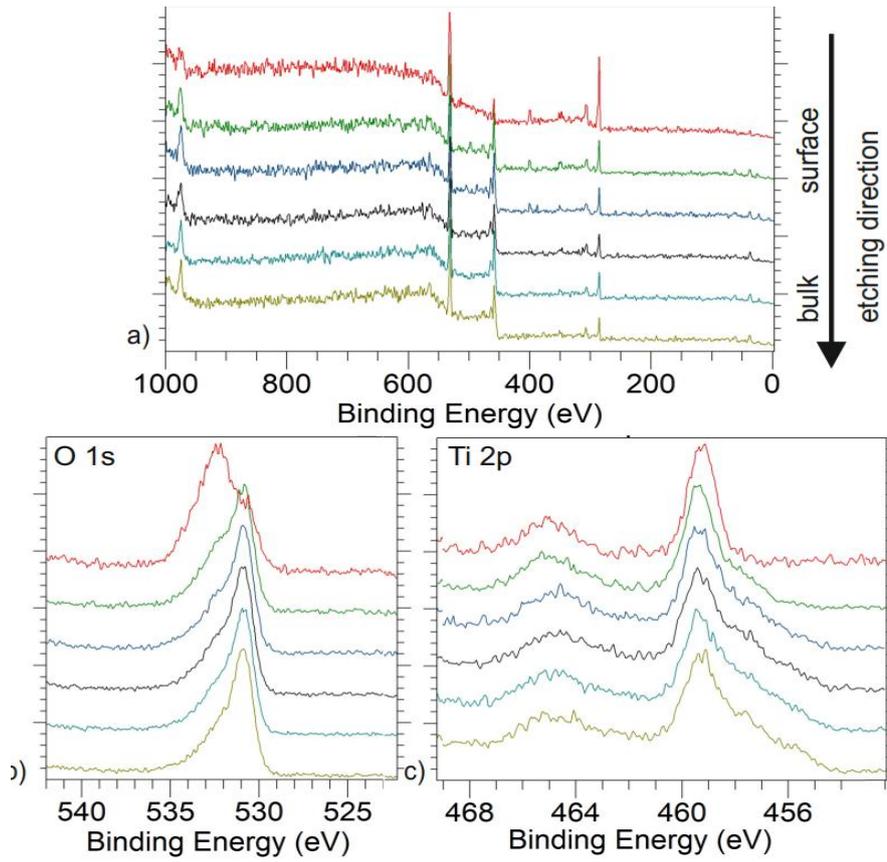
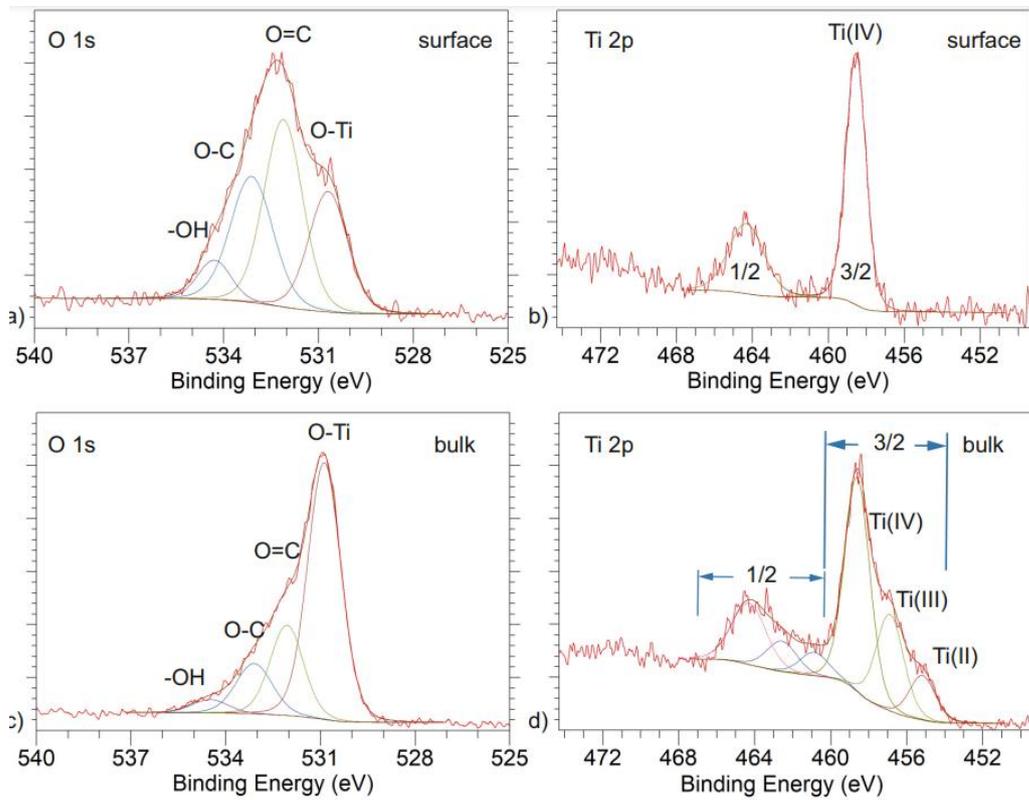
Figure 15 a) presents survey spectra of the surface scan as well as the consecutive scans upon ion depth profiling. Main and expected core lines are clearly visible, i.e. O 1s at ~530 eV, Ti 2p at ~460 eV, C 1s at ~284 eV. The trace N and Ca lines (at ~400 eV and 350 eV respectively) can be observed. However, together with carbon signal one can treat them as residual contamination since together with in-depth profile the mentioned signals are disappearing.

Figure 15 b) and c) presents the magnification of the regions of interest, i.e. O 1s and Ti 2p respectively. In O 1s spectrum, one can observe the significant decrease of the high binding energy branch and shift of the peak's center towards lower binding energies along etching procedure. In case of Ti 2p core level the single distinct component at ~458.5 eV (with its spin orbit splitting counterpart at ~465 eV) can be clearly observed for surface scan. The energy position points clearly the Ti(IV) oxide with near-stoichiometric composition [19]. For in-depth signals, however, one can notice additional contributions appearing below ~459 eV indicating sub-stoichiometric composition or other Ti oxidation states.

For precise description of the oxide composition these two regions (i.e. O 1s and Ti 2p) underwent detailed decomposition. Figure 16 a) and b) presents decomposition results for the spectra acquired for the initial (non-etched) surface for O 1s and Ti 2p

regions respectively. Next, panels c) and d) in Figure 16 shows the decomposition results of the bulk – related core levels after last ion etching procedure. One can see that the O 1s region (surface one) can be decomposed with four components representing (from lowest binding energy) O-Ti configuration, O=C, O-C/O-C-O and -OH configurations (14). The bulk signal (Figure 16 c)) is represented with the same components, however with significant decrease of the carbonaceous and -OH related species. This is consistent with decrease of the carbon signal along etching procedure (see Figure 15 a)). The main component (O-Ti), even if relatively narrow (i.e. ~1.35 eV full width at half maximum) does not however allow on titanium oxide composition description. Therefore Ti 2p analysis was also done. For the surface related Ti 2p region (Figure 16 b)) presents distinct Ti 2p 3/2 signal with its spin-orbit splitting 1/2 counterpart. The 1/2 to 3/2 energy distance as well as the 3/2 energy position points near-to stoichiometric Ti (IV) oxide with no suboxides (the FWHM is below 1.18 eV). After the etching process, for the bulk region (Figure 16 d)) two additional components appears at ~456.8 eV and at ~455.2 eV. The energy positions indicates that the most probable configurations are Ti (III) and Ti (II) oxides respectively [19]. However, the dominating one (>80 % of the overall signal) is still Ti (IV) oxide with main component at ~458.7 eV [2,3] which is important, no TiO state was detected.
